WILDERNESS CAMP DAM

RAY COUNTY, MISSOURI

MO. 11221

**PHASE 1 INSPECTION REPORT
NATIONAL DAM SAFETY PROGRAM**

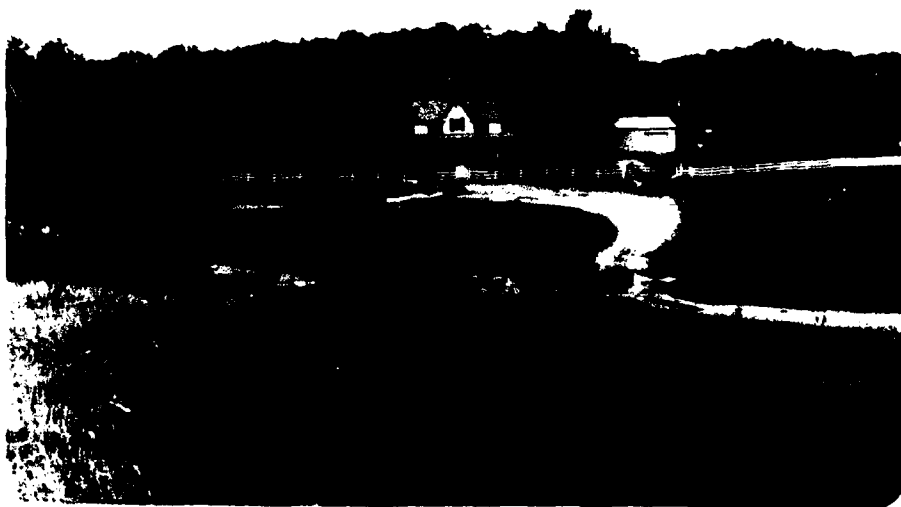
PHOTO NO. 24 - DOWNSTREAM HAZARD ON LEFT BANK APPROXIMATELY
ONE HALF MILE DOWNSTREAM

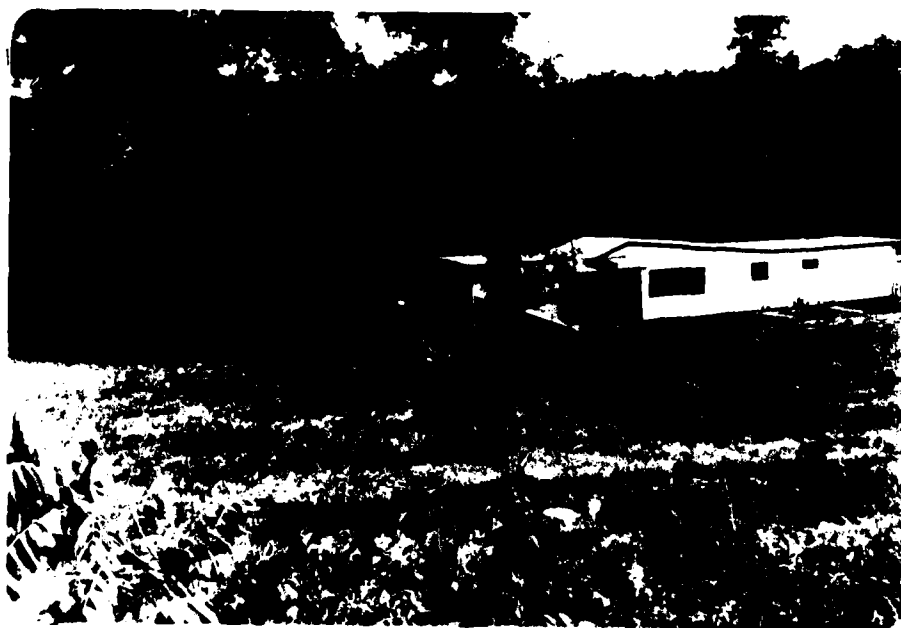
PHOTO NO. 25 - DOWNSTREAM HAZARD ON RIGHT BANK APPROXIMATELY
3/4 MILE DOWNSTREAM
